USABAAR

OH-58 ACCIDENT SUMMARY

May 1969 through February 1971

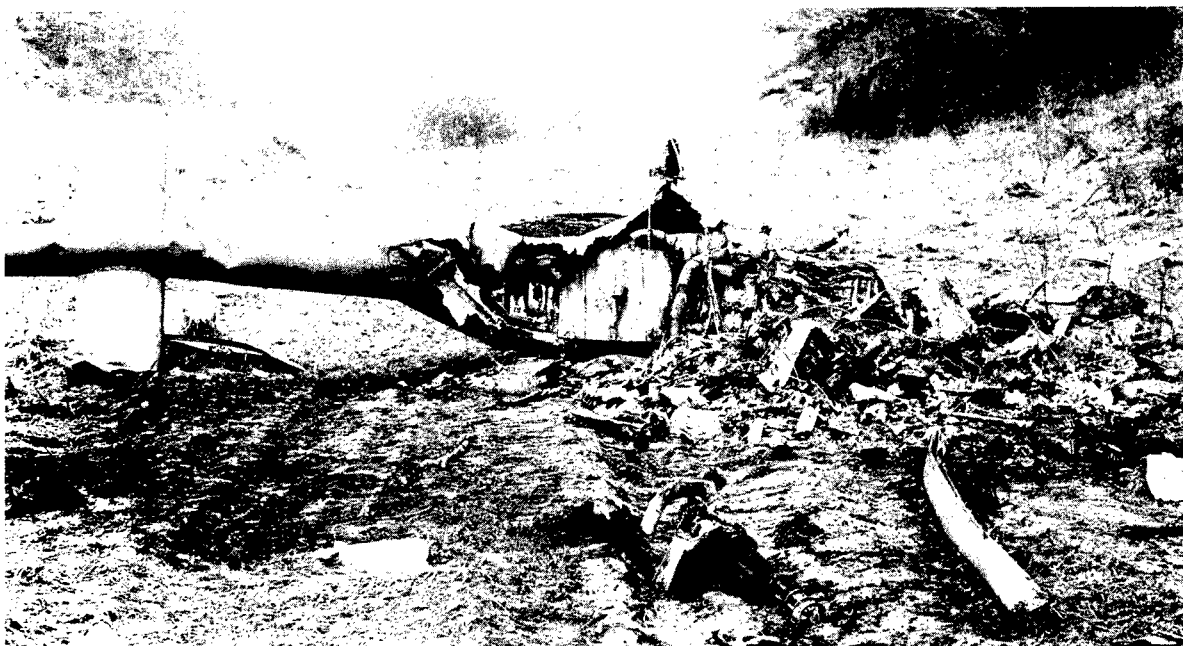
70040902--During low-level flight in a valley under conditions of rain, snow, and fog, aircraft struck powerlines and crashed. The pilot and observer were fatally injured and the aircraft was destroyed by postcrash fire. Caused by flying at unnecessarily low altitude and high airspeed for mission accomplishment, and failing to respond to warning of imminent wire dangers. Probable or suspected cause factors were (1) improper supervision within the unit of flight planning procedures and disregard of basic safety regulations, and (2) false impression on the part of the pilot that the powerlines ran parallel to the intended route of flight.

70040902 - Pilot failed to respond to warning of imminent wire dangers.
